# P 23 086 SUPERSEDED BY P 23 145

## P 23 086 WVA (23711-23712) → P 23 145 (WVA 23711-23713)

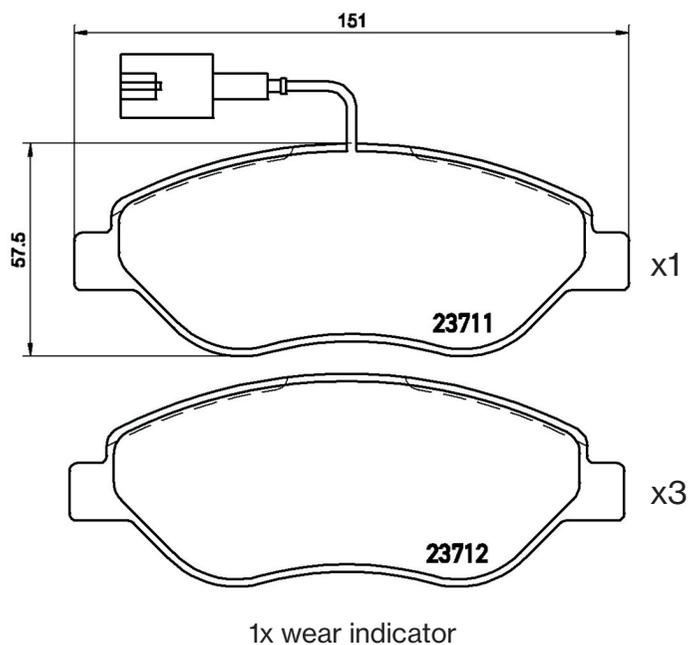
### P 23 086

For the reference P 23 086, Fiat changed the corresponding OES reference from one wear indicator to two wear indicators per set. Wear indicators that are not used have to be simply cut off during assembly. Brembo will perform the same change, according to the OES programme. P 23 086 will be replaced by P 23 145

Existing stock of P 23 086 can be sold out. Please consider that P 23 086 can be used only for vehicles equipped with one wear indicator.
