P 61 090 SUPERSEDED BY P 23 143

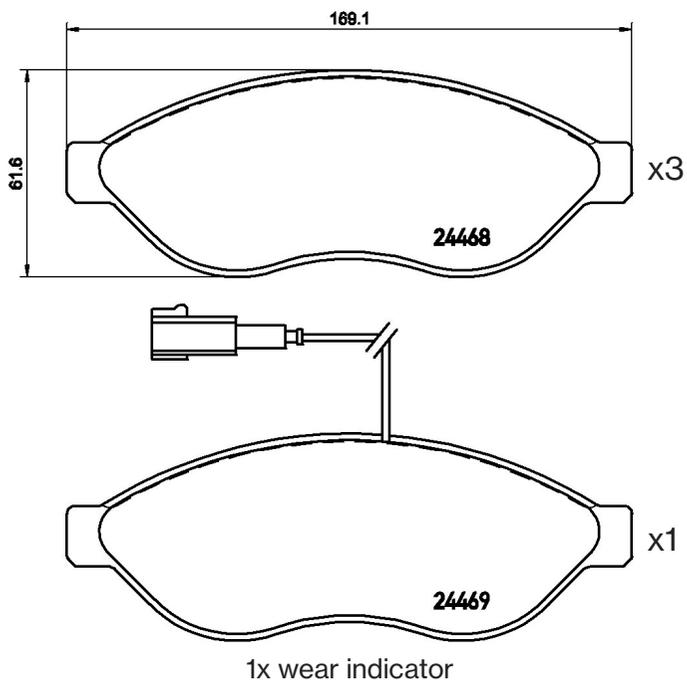
For the reference P 61 090, Fiat changed the corresponding OES references from one wear indicator to two wear indicators per set. Wear indicators not used have to be simply cut off during assembly. Brembo will perform the same change, according to the OES programme. P 61 090 will be replaced by P 23 143.

Existing stock of P 61 090 can be sold out. Please used only on vehicles equipped with one wear indicator.
